TECHNICAL MEMORANDUM

Field Reconnaissance of Hanna Stope

July 22, 1999

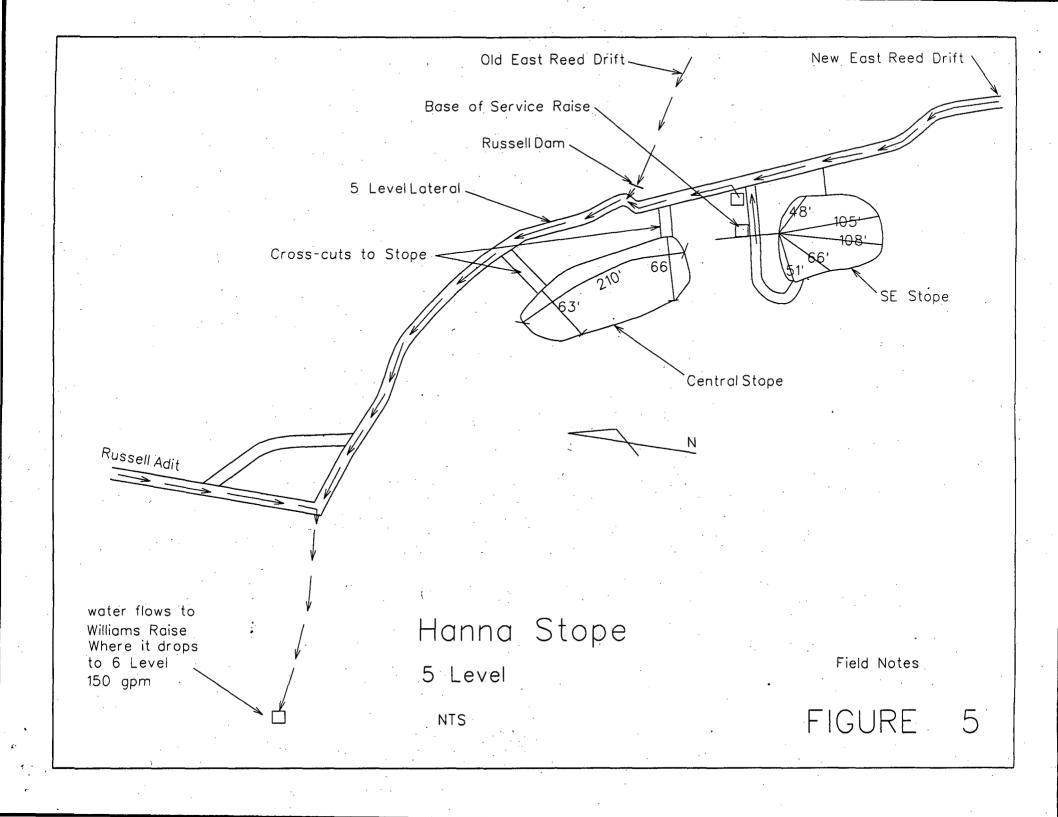
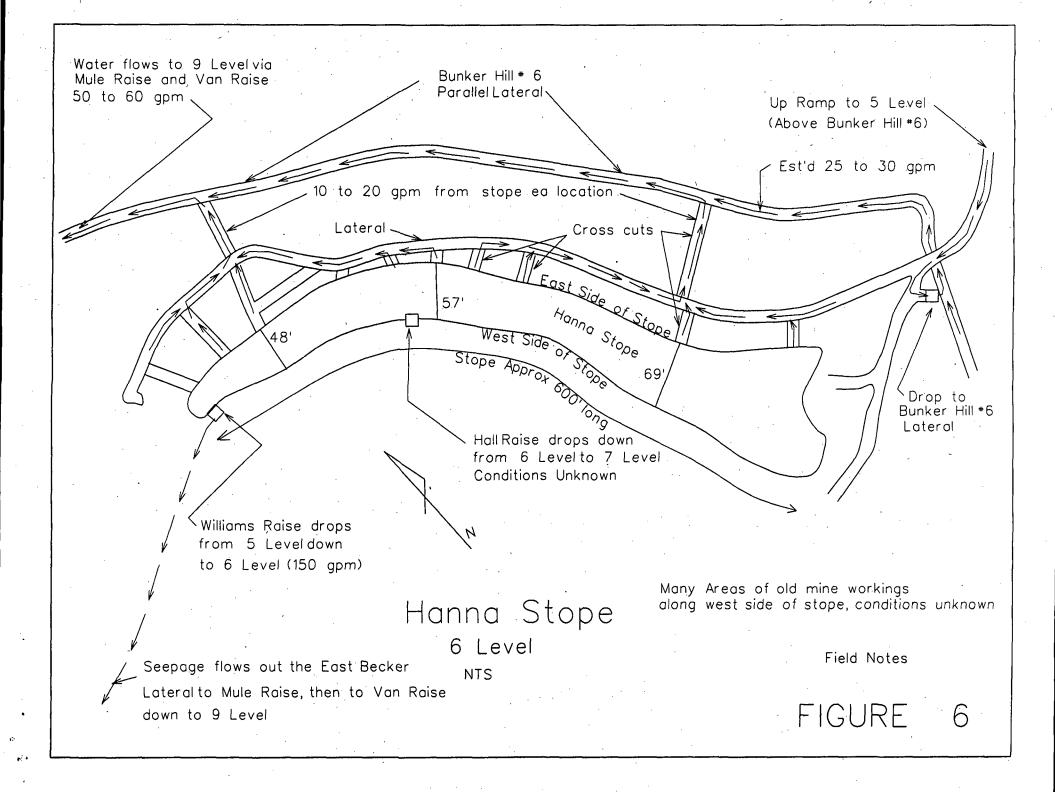
Second Sublevel Below 2 Level

attempt to access the third sublevel because of poor access conditions from the service raise. We did, however, stop at the second sublevel and the first sublevel below 2 Level. The Hanna stope was not observed above the second sublevel below 2 Level. We returned to the Sullivan No. 2 Adit entrance via the same route from which we entered the mine.
